Manufacturing | Smelter Operations | Termination Defects Detected with IIoT Continuous Monitoring

Our client operates a PGM group smelter situated outside of Polokwane. The current infrastructure comprises a 68MW furnace fed by 33kV single-core cables. The concentrate is melted by energy generated when an electric current passes through the electrodes and resistive slag layer. On melting, two immiscible phases form: slag and matte. The furnace matte, containing the bulk of the base metal sulphides and PGMs, is denser than slag and collects naturally at the bottom of the furnace. Electricity is the single most significant input cost for smelting platinum concentrate in the electric furnace and, therefore, must have a reliable power supply. This requires that all the electrical assets are available 100% of the time and that these are monitored 24/7 to ensure reliability

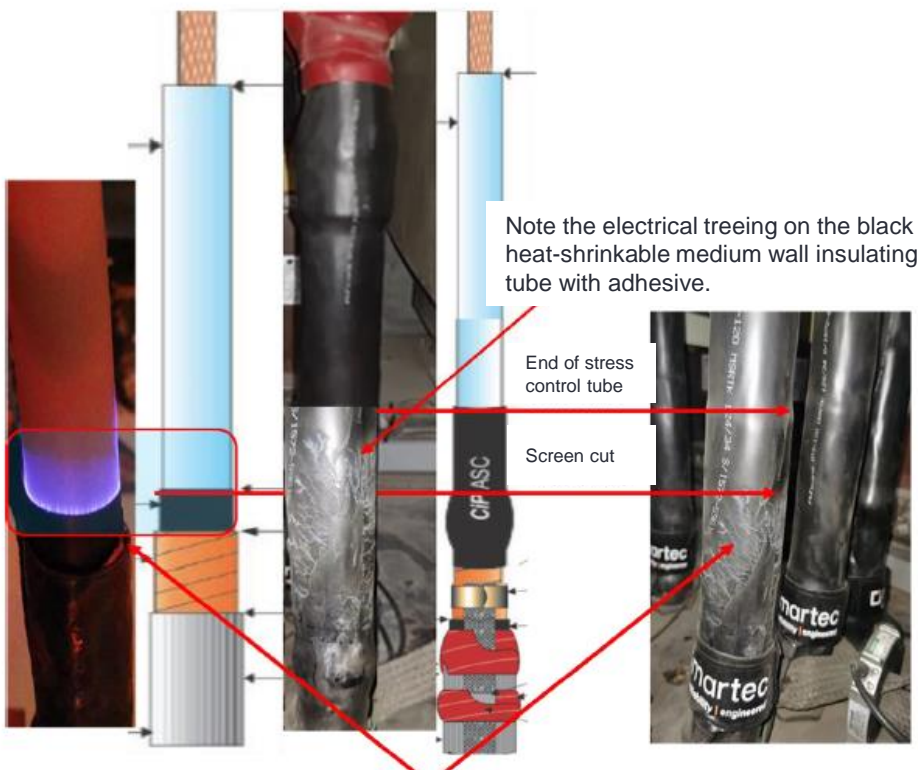
HV test findings of the yellow 3 termination

A high voltage 50hz test set was connected to the termination. The positive lead to the termination lug and the high voltage earth connected to the termination earth strap.

The termination earth strap was folded over the black tube and secured with roll-springs. This setup is to prove the tracking that will take place on the black tube, causing the electrical trees.

Black heat-shrinkable medium wall insulating tube with adhesive. These tubes must not be used on 33kV terminations.

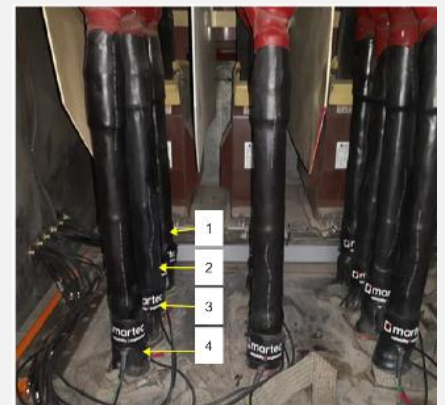
- Screen cut done incorrectly
- Causes discharges as shown

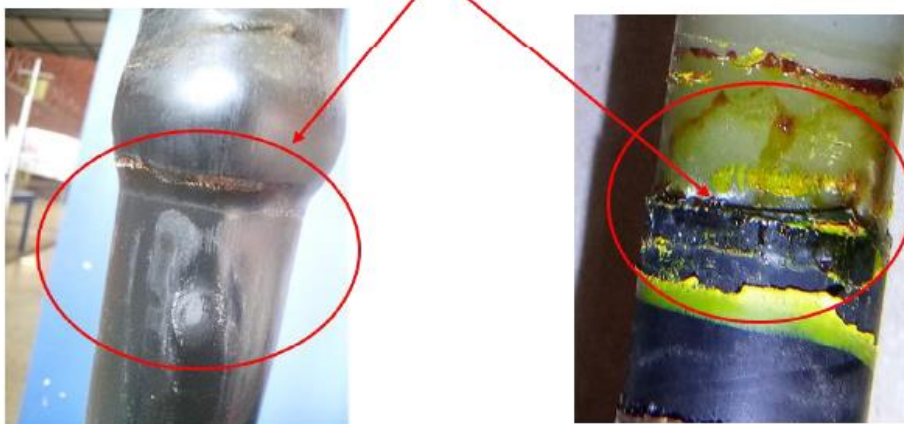
Discharges will be created if the screen cut is damaged or badly cut during installations
